REP-REP-RAE8451-5145187    Remove and install trim of instrument panel (steering column shroud, lower part) lower left side

51 45 187

Remove and install trim of instrument panel (steering column shroud, lower part) lower left side

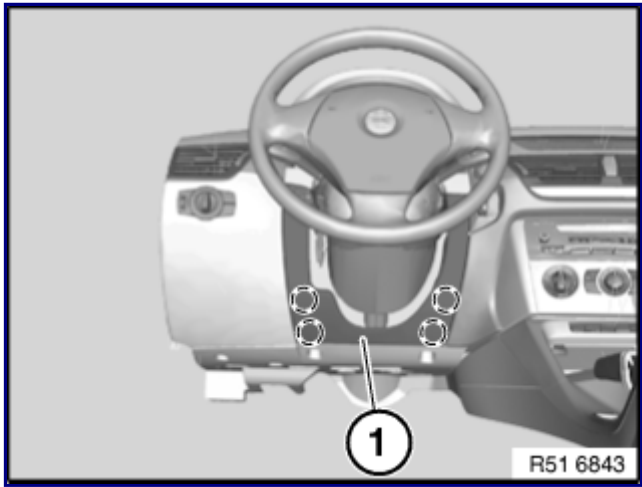
Remove clamps (highlighted area) from steering column shroud (1).

Remove steering column shroud (1).

Clamps and retaining tabs must not be damaged.

Cleanly press in steering column shroud (1).
