REP-REP-RAE8451-5145180 Removing and installing/replacing instrument panel trim, bottom left

VIN: XXXXXXX Vehicle: X'/E84/OFF-ROAD VEHICLE/X1

28iX/N20/AUTO/USA/LL/2013/12

Removing and installing/replacing instrument panel trim, bottom left

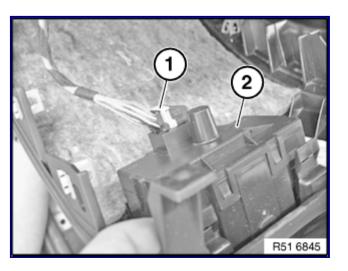
Release screws (1) from lower dashboard trim panel (2).

Release plug connection (1) on light switch (2) and disconnect. Remove lower instrument panel trim.

- Modify light switch
- Modify retaining clips and sheet metal nuts and renew if necessary.
