51 49 000

Removing and installing or replacing trim  
for tailgate

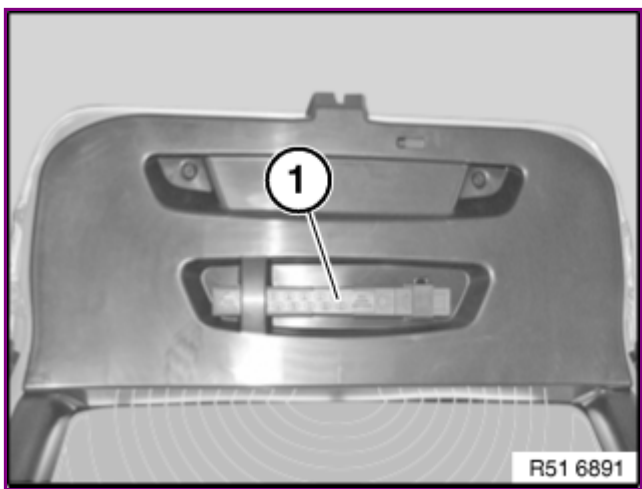
Remove warning triangle (1).

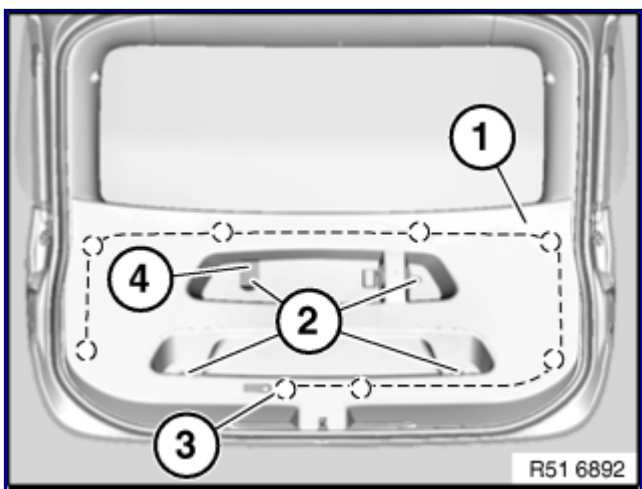
- Release screw (2) from warning triangle holder (4).
- Remove warning triangle holder (4).
- Release remaining bolts (2).
- Use appropriate tool to unclip trim panel (see highlighted area) from tailgate (1).
- US version only
  - Feed out tailgate lock with emergency release (3).
- Remove panel for tailgate (1).
