51 49 000

Removing and installing or replacing trim
for tailgate

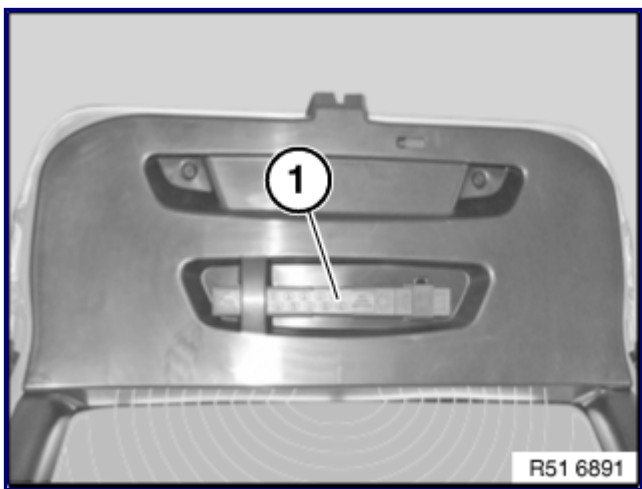
Remove warning triangle (1).

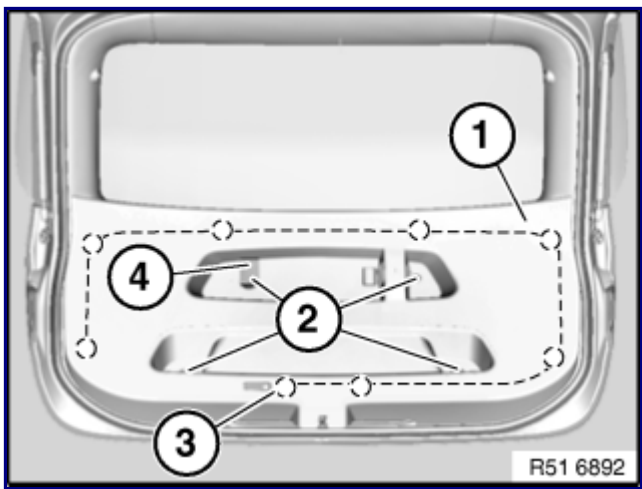
- Release screw (2) from warning triangle holder (4).
- Remove warning triangle holder (4).
- Release remaining bolts (2).
- Use appropriate tool to unclip trim panel (see highlighted area) from tailgate (1).
- US version only
 - Feed out tailgate lock with emergency release (3).
- Remove panel for tailgate (1).

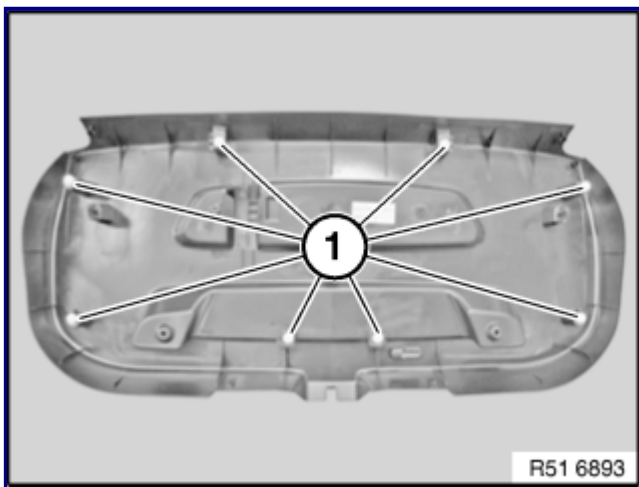
- Installation:*
- Replace faulty clips (1).
 - Insert trim of tailgate properly.
 - US version only
 - Properly feed through emergency release of tailgate lock.
- Replacement**
- Modify clips (1).
